Intel® Desktop Board D865GBF Specification Update

Release Date: November 2004

Order Number: C41597-013

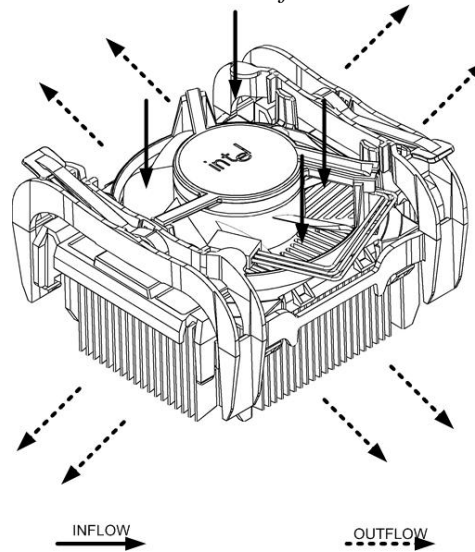
Figure 29a. Omnidirectional Airflow Heatsink

- A chassis with a maximum internal ambient temperature of 38 Degrees Celsius
- A processor heatsink that provides omnidirectional airflow so that air is drawn across the processor voltage regulator area (item A in Figure 30). Figure 29a illustrates an omnidirectional airflow heatsink.

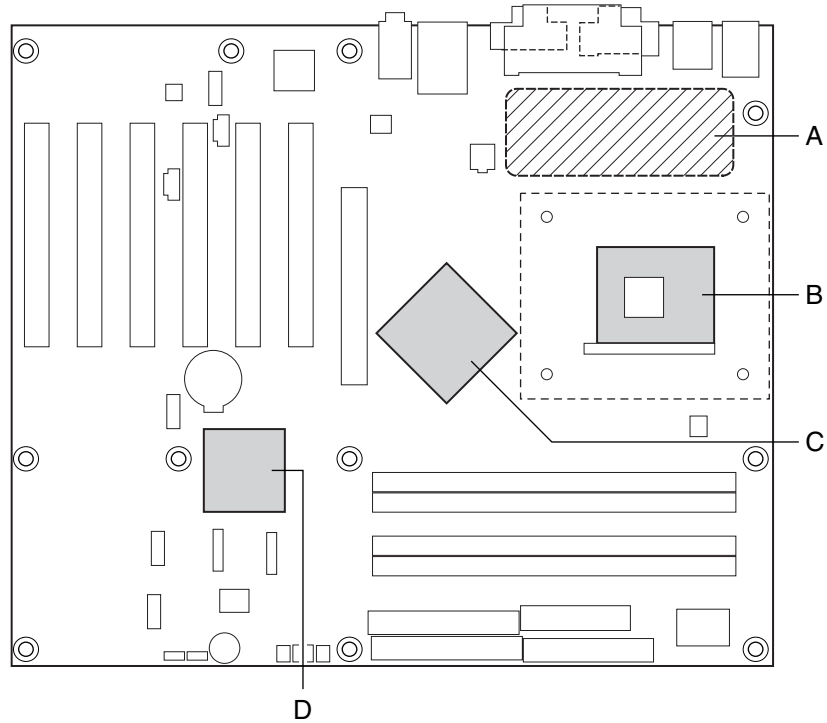
Figure 30. Localized High Temperature Zones

Figure 30 shows the locations of the localized high temperature zones.

Item	Description
A	Processor voltage regulator area
B	Processor
C	Intel® 82865G GMCH
D	Intel® 82801EB ICH5

Ensure that proper airflow is maintained in the processor voltage regulator circuit. Failure to do so may result in damage to the voltage regulator circuit. The processor voltage regulator area (item A in Figure 30) can reach a temperature of up to 85 °C in an open chassis.
